Pedestrian Road Safety Audit

University Boulevard (MD 193) and Colesville Road (US 29)

Montgomery County, Maryland

July 2011

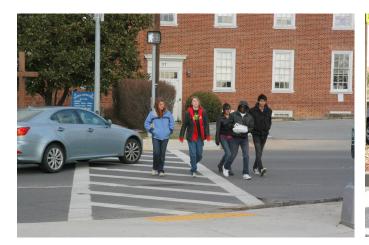
Figure 10: Pedestrian Conflicts with Turning Vehicles

Pedestrian-Vehicle Conflicts – Most pedestrian conflicts in the study area occur as pedestrians cross Colesville Road or University Boulevard. The relatively high traffic volumes, the distance to cross four or more lanes, and significant pedestrian activity in the study area lead to relatively high exposure levels for pedestrians in the area. Pedestrians were also observed violating pedestrian signals routinely. Possible contributing factors include long pedestrian wait times and long signal timings.

Both right and left-turning traffic was observed to conflict with pedestrians at the Colesville Road/University Boulevard EB intersection. These conflicts may deter students from crossing at crosswalks.

Safety Issue	Suggestions
Pedestrian - Vehicle Conflicts	 Consider signage to improve driver awareness of pedestrians and reduce turning movement conflicts at intersections. (ST) Evaluate pedestrian signal timing. (I) Determine the feasibility of geometric roadway improvements to reduce pedestrian crossing distances or improve pedestrian refuge spaces. (I) Remove or relocate obstructions in sidewalk. (ST) Ensure appropriate levels of enforcement. (LT)

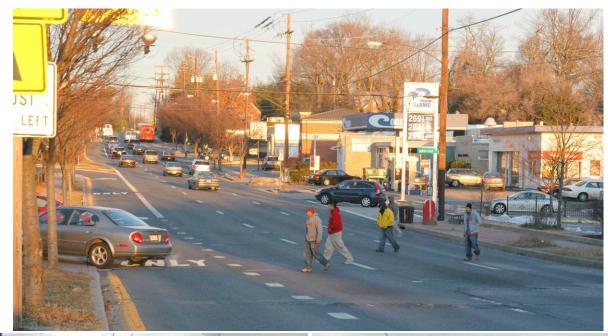
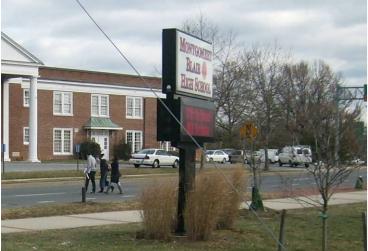
Figure 11: Uncontrolled Mid-block Crossings

Uncontrolled Mid-block Crossings – Uncontrolled mid-block crossings refer to pedestrians crossing roadways at locations away from intersections and without a designated crossing treatment, such as a crosswalks or pedestrian signal. Uncontrolled mid-block crossings are prevalent throughout the corridor and were identified as one of the primary contributing factors to pedestrian collisions in the study area. Possible causes of uncontrolled mid-block crossings are the locations of various land uses, including the Blair High School and various commercial land uses, on all sides of the intersection and within the parcels between University Boulevard EB and WB. Additionally, the locations of bus stops may contribute to uncontrolled mid-block pedestrian crossing activity.

Multiple people cross University Boulevard WB between McDonald's and the bus stop near Sutherland Road (top). A pedestrian crosses the Colesville Road northbound lanes (north of University Boulevard WB) to the median after disembarking from a bus (lower left). High school students cross University Boulevard EB from the brick pavers in front of the high school (lower right).

Safety Issue	Suggestions
Mid-block Crossings	 Consider signage to improve driver awareness of pedestrians. (ST) Determine the feasibility and constructability of installing median or roadside barriers to deter mid-block crossings. (I) Consider streetscape features and improvements to impede pedestrians from crossing at mid-block locations. (I) Work with MDSHA to designate this area as a school zone and installing signage, flashing beacons, and pavement markings. Implement a pedestrian education program. (LT) Ensure appropriate levels of enforcement and perform targeted enforcement. (ST) Identify potential mid-block locations to conduct a pedestrian warrant study for a signalized or high-visibility pedestrian crossing. (I) Post additional speed limit signs where appropriate. (I)
Unmarked Crossing	 Install high-visibility crosswalks at locations where markings
Locations	should be provided or where existing crosswalks are faded. (ST)

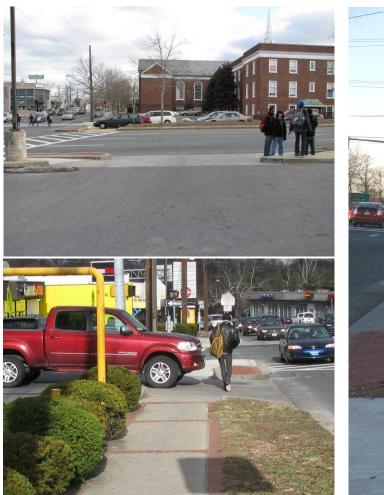
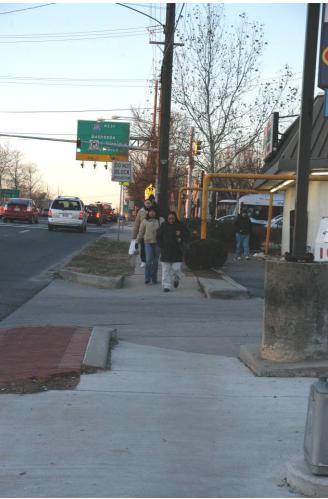
Figure 12: Commercial Driveway on Colesville Road

Conflicts at Driveway Locations – Commercial land uses throughout the study area contribute to significant turning movements at driveways. Driveways can introduce conflicts between pedestrians and motorists, often as a result of drivers watching for other vehicles rather than pedestrians. Closely spaced driveways increase opportunities for conflict between pedestrians and vehicles and can deter pedestrians from walking on sidewalks, in order to avoid conflicts with vehicles.

No pedestrian warning or entry prohibition signage is provided at the commercial driveway (upper left). Curbing along the wheel chair ramps (right) and vegetation at the back of sidewalk (lower left) tend to encourage pedestrians to cross in front of waiting vehicles. The crash data for this location suggests drivers are more focused on gaps in traffic than pedestrians on the sidewalk.

Driveway Access Conflicts	 Consider pavement markings, such as stop bars, to discourage vehicle encroachment on pedestrian crossing paths. (ST) Consider signage to improve driver awareness of pedestrian activity and reduce conflicts at driveways. (ST) Work with the business community to pursue physical modifications to driveways and sidewalks to reduce conflicts at driveways. (LT) Explore the use of different paving materials on or along sidewalks at conflict areas to delineate pedestrian pathways. (I) Remove vegetation that limits pedestrian-vehicle visibility. (I)
Adverse Signage Placement or Condition Limited Bus Stop Waiting Areas	 Re-posting signage at standard heights and distances from the roadway. (ST) Replace missing signage. (ST) Relocate obstructed traffic control signage or remove obstructions. (ST) Re-orient pedestrian crossing signage to ensure visibility by pedestrians. (ST) Upgrade outdated signage. (ST) Assess potential sight line obstructions when vegetation is in full bloom. (I) Coordinate with Transit Services to pursue expanding pedestrian landings and bus stop waiting areas; and installing additional bus

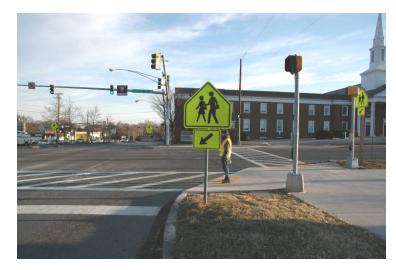
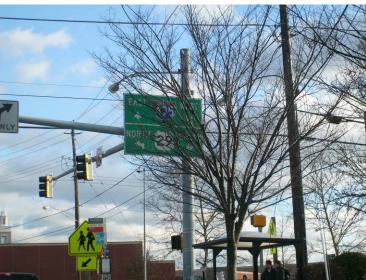
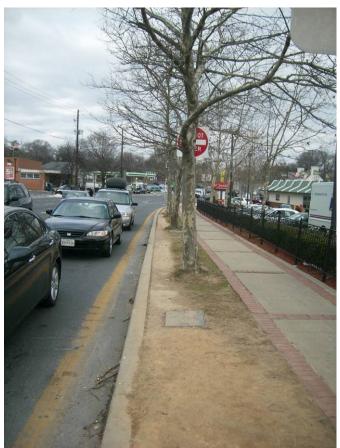
Figure 13: Signage Obstructions

Adverse Signage Placement or Condition – A number of traffic control and warning signs are posted in locations that obstruct vehicle sight lines or are blocked by vegetation. Additionally, some signs were observed to be missing, faded, or worn.

Photos from the Colesville Road at University Boulevard EB intersection (clockwise from upper left): Pedestrian warning signage at the SE corner is posted too low and close to roadway, potentially blocking driver sight lines of waiting pedestrians. Do Not Enter sign on west leg is blocked by a tree. Vegetation on the SW corner partially obstructs eastbound driver views of the overhead directional signage, even in winter.

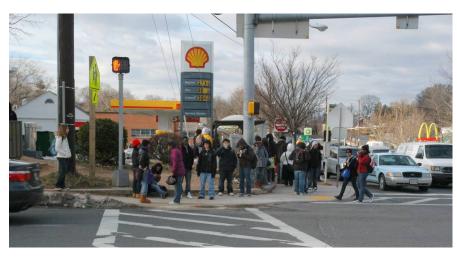
Figure 14: Bus Stop Crowding and Sight Obstructions

Limited Bus Stop Waiting Area – Significant crowding was observed at a number of bus stops in the study area during periods of peak activity. The crowding at these locations contributes to pedestrians standing very close to roadways and traffic traveling at relatively high speeds. Pedestrians were observed standing in unexpected places, having difficulty passing on the sidewalks (leading to unexpected pedestrian routes on the roadway or private property), and obstructing driver sight distance.

Large groups of pedestrians waiting for transit buses along Colesville Road and University Boulevard (left) leave little or no room for pedestrians to pass along the sidewalk and obstruct visibility of the south leg crosswalk for right-turning vehicles. Pedestrians occupy the entire sidewalk and stand close to traffic traveling in excess of 45 mph on southbound Colesville Road, south of University Boulevard EB (right).
